STORMONT MADUBELA PRIMARY SCHOOL

RENOVATION OF THE SCHOOL FACILITIES

FINAL REPORT 15.05.2016

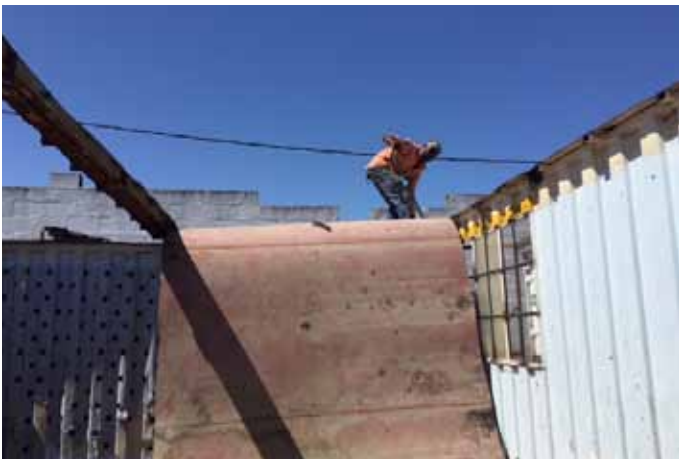
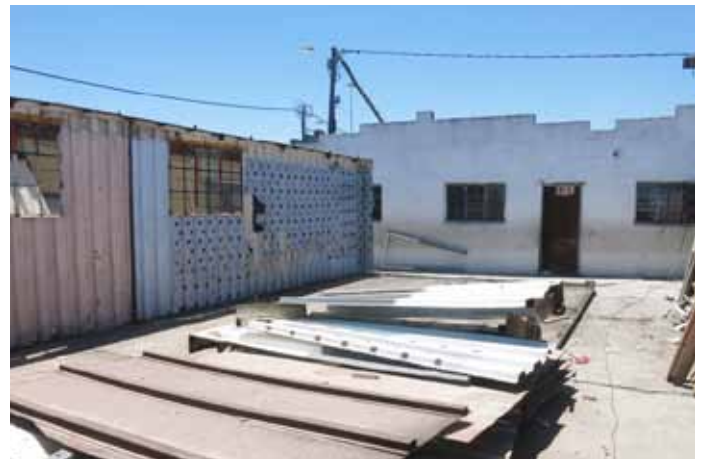
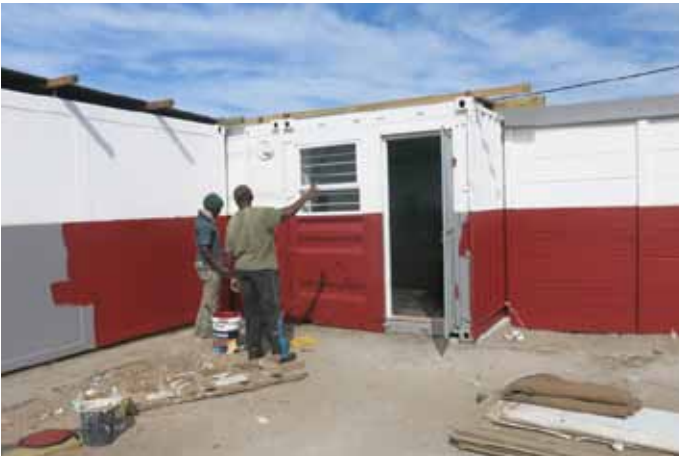
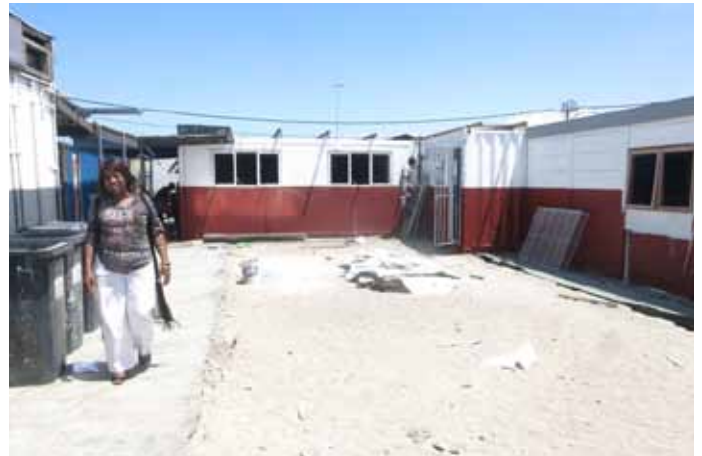
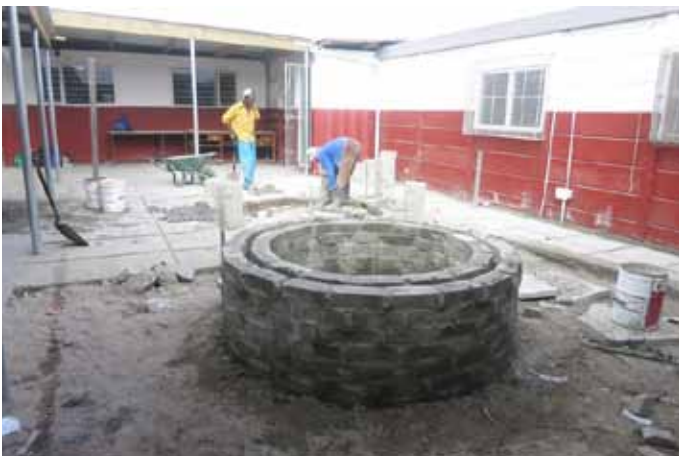
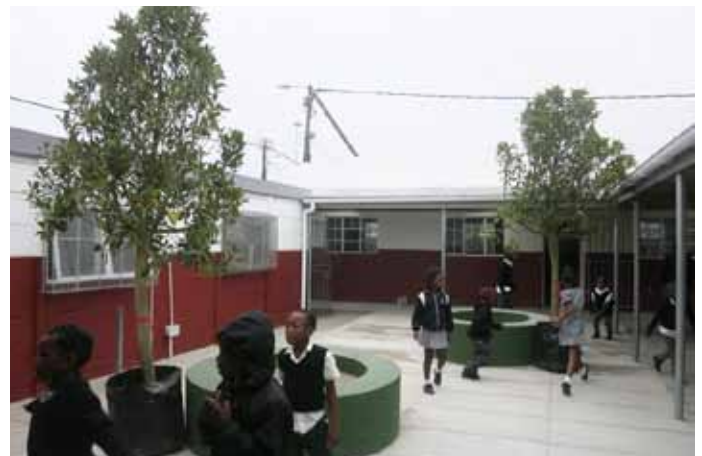
1. removal 4x 12m classroom 2 container alongside courtyard and creation of new courtyard

Two container classrooms (each 2 combined 12m container) alongside the courtyard showed sagging roof and bad corrugation damages, both were at risk of collapsing and had to be replaced.

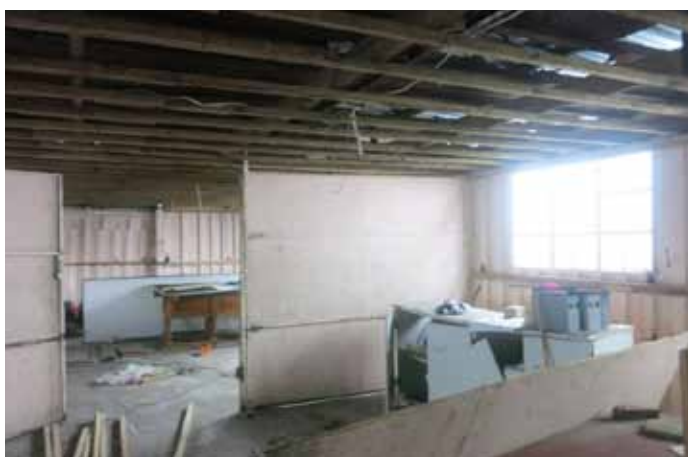
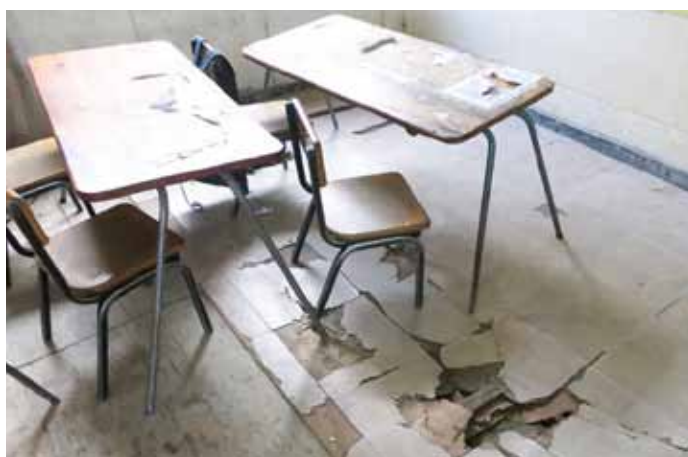
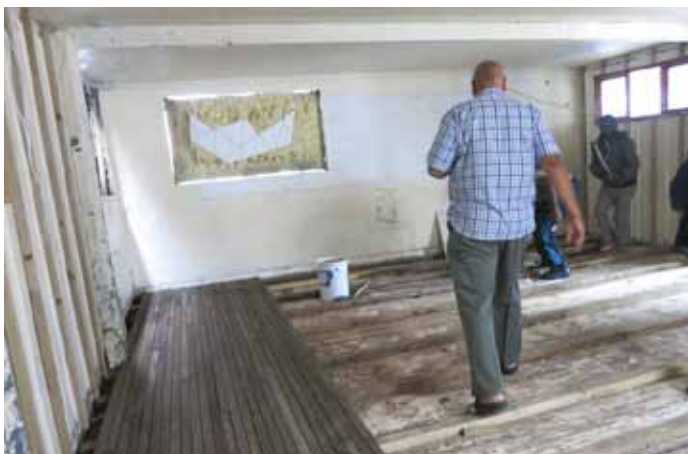
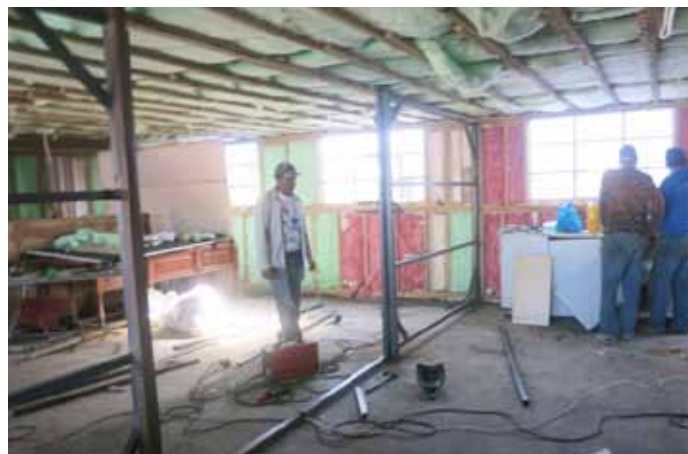
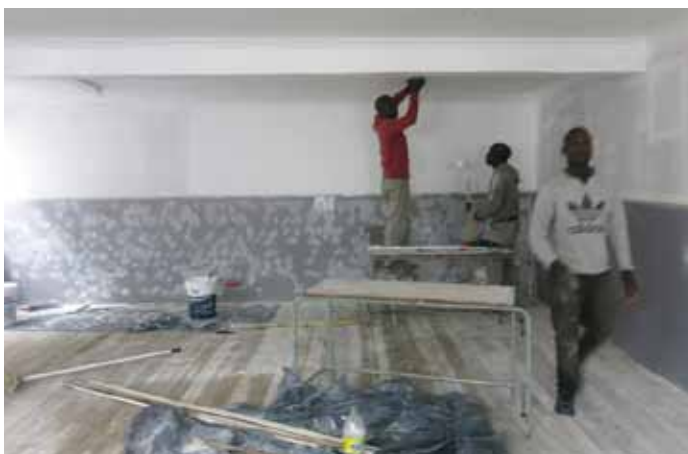
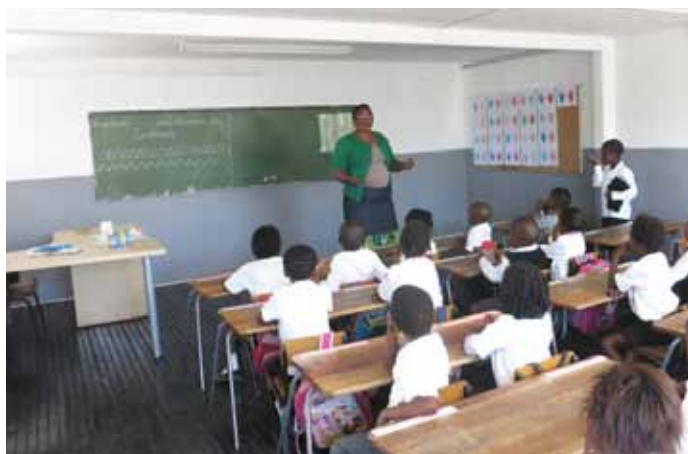
3. renovation 4 existing classrooms container 1, 4, 5, 8

All indoor spaces, steel containers as well as brick buildings, showed severe damages: most floors, walls, ceilings, windows, doors, electrical systems and furniture were worn off, broken or corrugated. Most roofs were leaking. Some windows did not close, most doors did not lock. Only few window burglar bars were in place, all door burglar gates have been stolen.

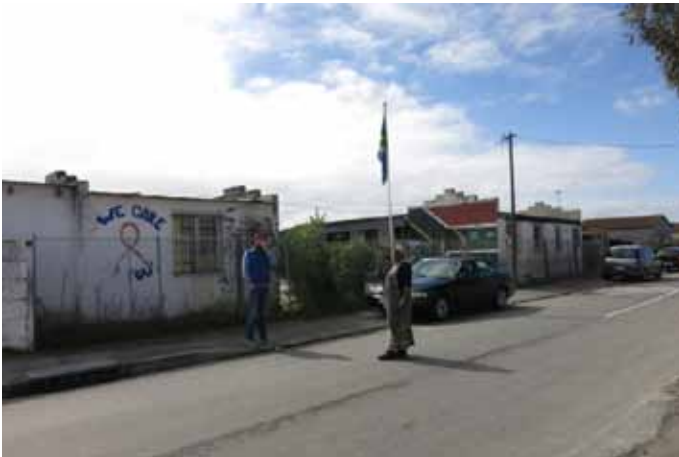
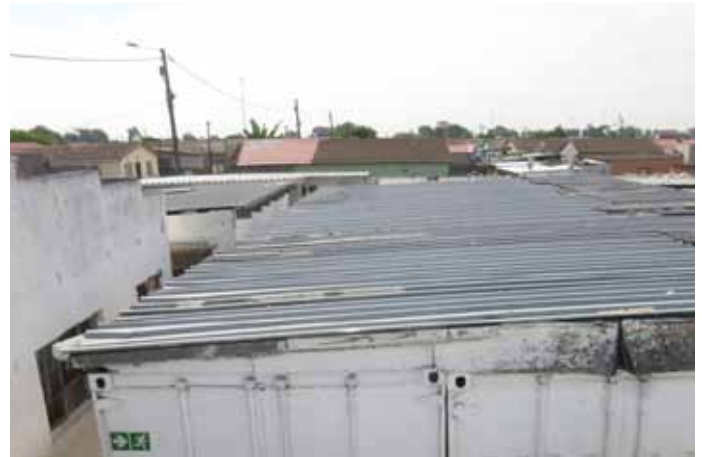
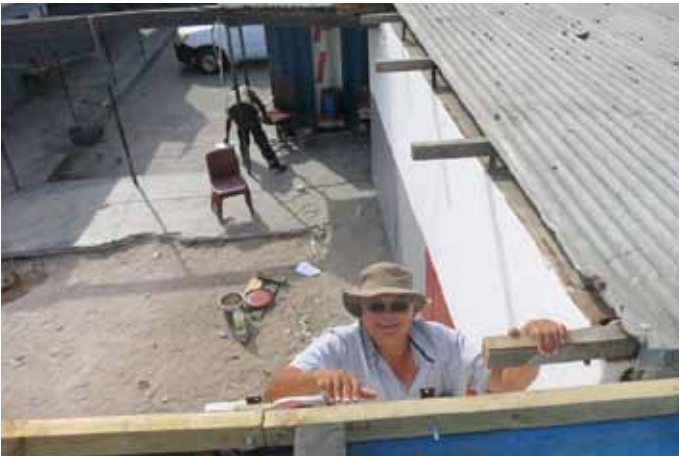
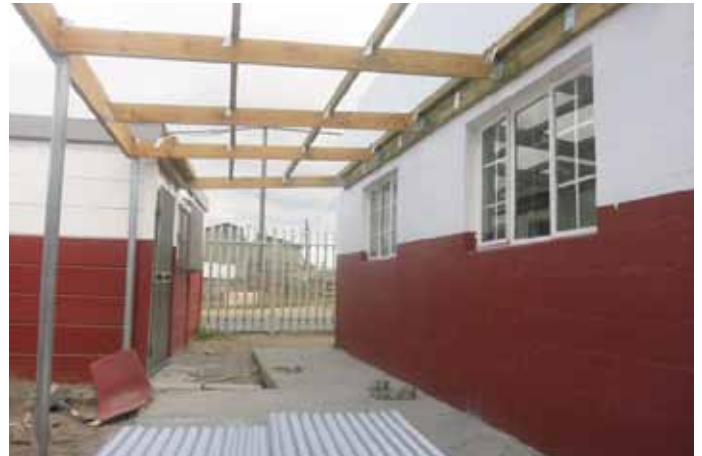
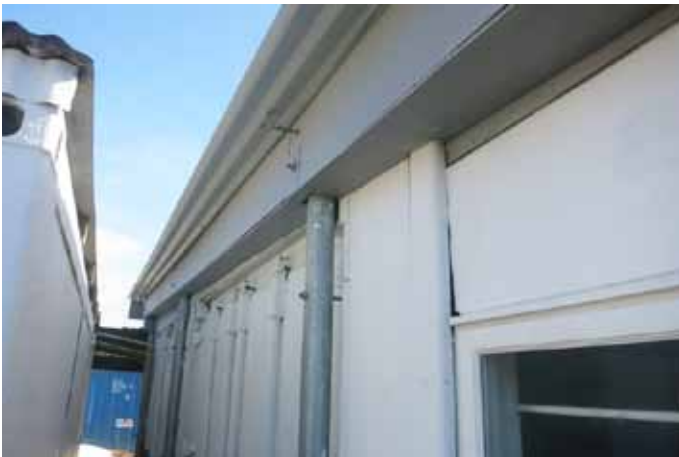
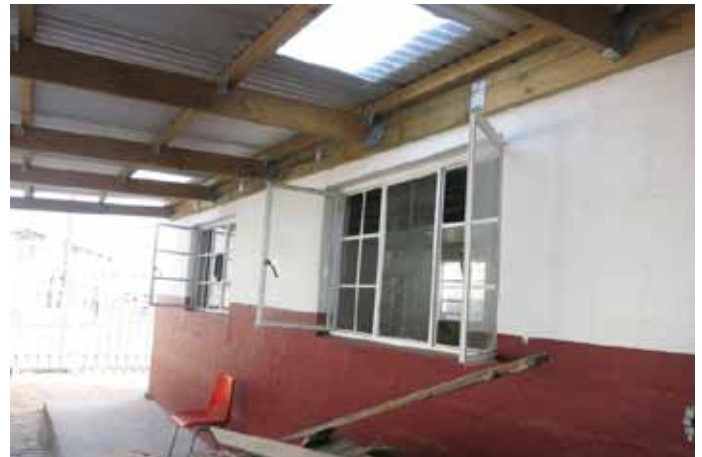
7. replacement or repair of all roof structures and sheeting, construction of some new cannopees

- . all roof sheeting and the timber construction was in a worse condition than expected and required replacement in most areas
- . the electrical system of the entire facility was wired in an improvised and dangerous way, the system was not earthed and needed to be professionally rewired.
- . due to safety risks, further security measures were taken and features were installed.
- . to keep up public buy-in and community support, the project manager put emphasis on the liaisons and communication with relevant stakeholder.
