STORMONT MADUBELA PRIMARY SCHOOL

RENOVATION OF THE SCHOOL FACILITIES

FINAL REPORT 15.05.2016

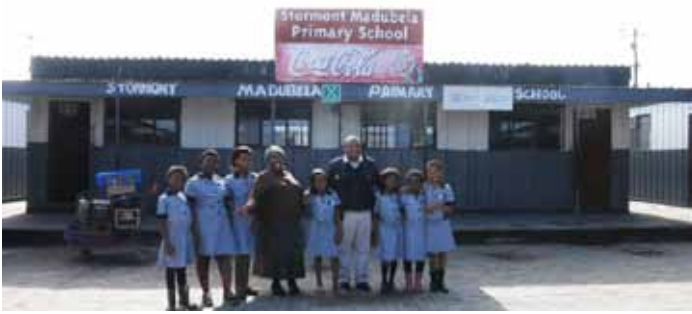
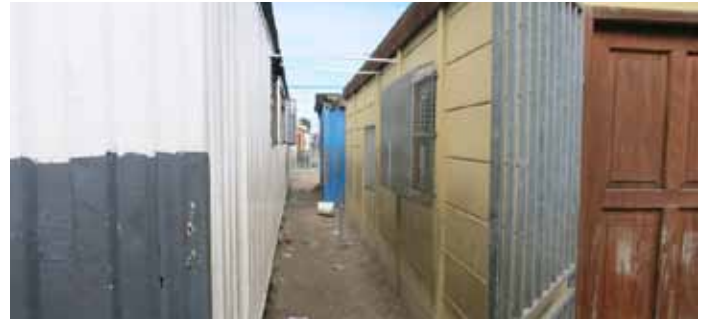
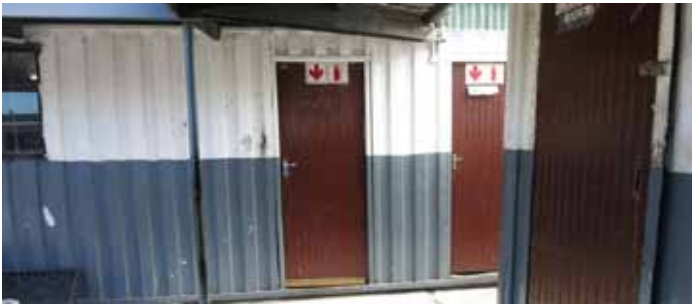
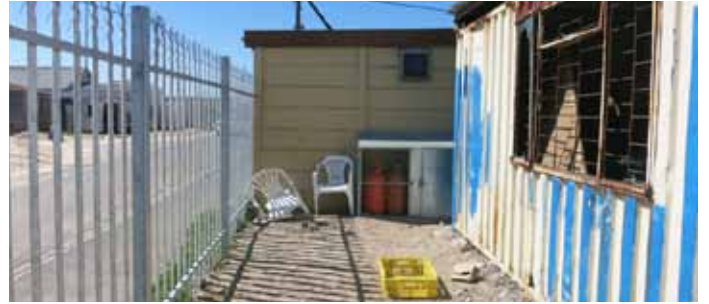
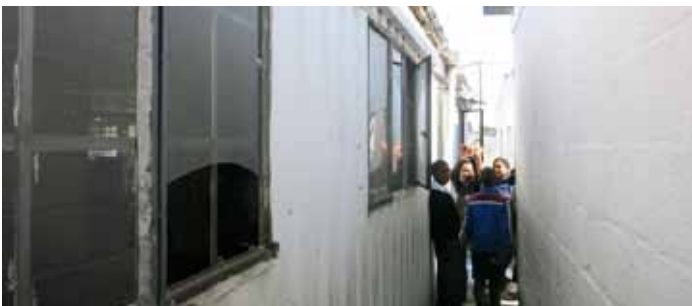
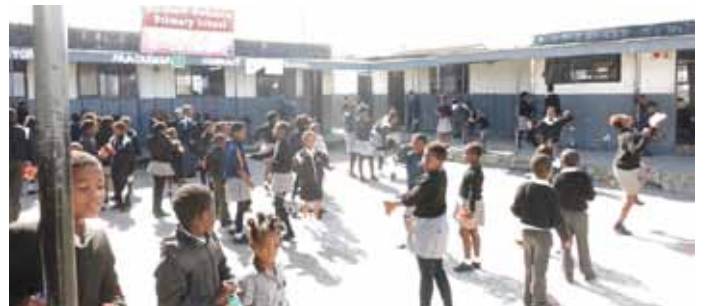
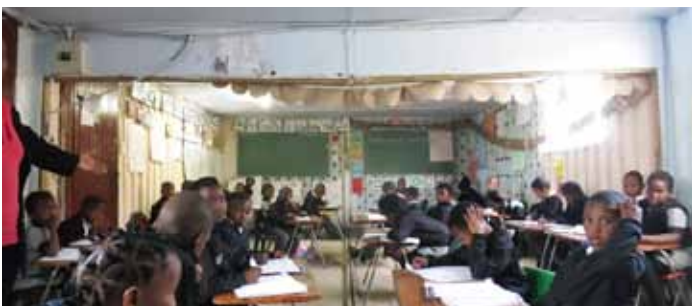
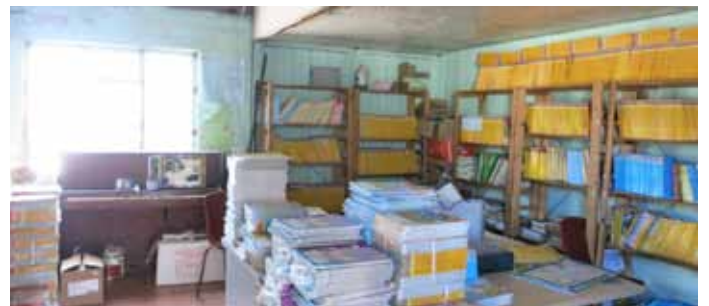
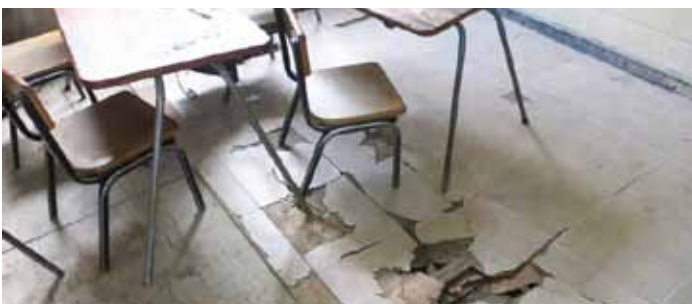
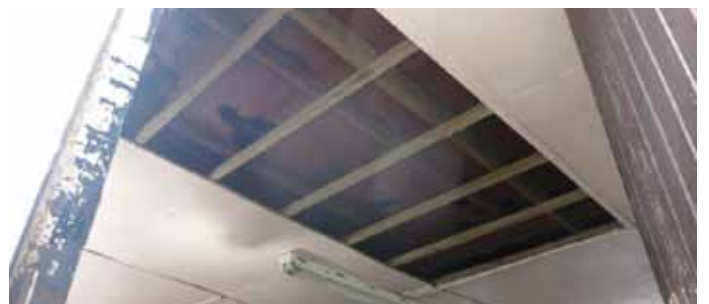
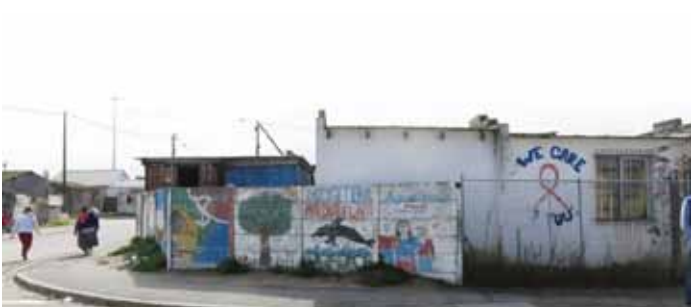
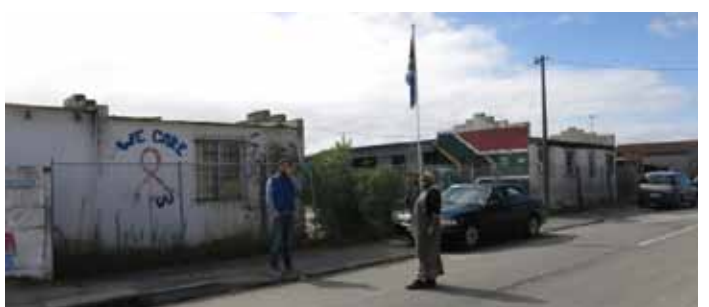
SITUATION BEFORE UPGRADE

The existing facilities are highly deteriorated, the condition of the structures was in a critical stage: Most load bearing elements were acceptable structural condition.

Two container classrooms (each 2 combined 12m container) alongside the courtyard showed sagging roof and bad corrugation damages, both were at risk of collapsing and had to be replaced.

All indoor spaces, steel containers as well as brick buildings, showed severe damages: most floors, walls, ceilings, windows, doors, electrical systems and furniture were worn off, broken or corrugated. Most roofs were leaking. Some windows did not close, most doors did not lock. Only few window burglar bars were in place, all door burglar gates have been stolen.

External concrete walkways and canopies framing the courtyard were in acceptable condition. External corridors and open spaces between containers were mostly un-paved and sandy, extremely narrow and did not comply with fire protection regulations. Open spaces behind container classrooms were not visually overseen, therefore unsafe and dirty.
